## Review of California's Rural Intersection Crashes: Application of Methodology for Identifying Intersections for Intersection Decision Support (IDS)

Report #8 in the Series: Toward a Multi-State Consensus on  
Rural Intersection Decision Support

**Final Report**

**October 2008**

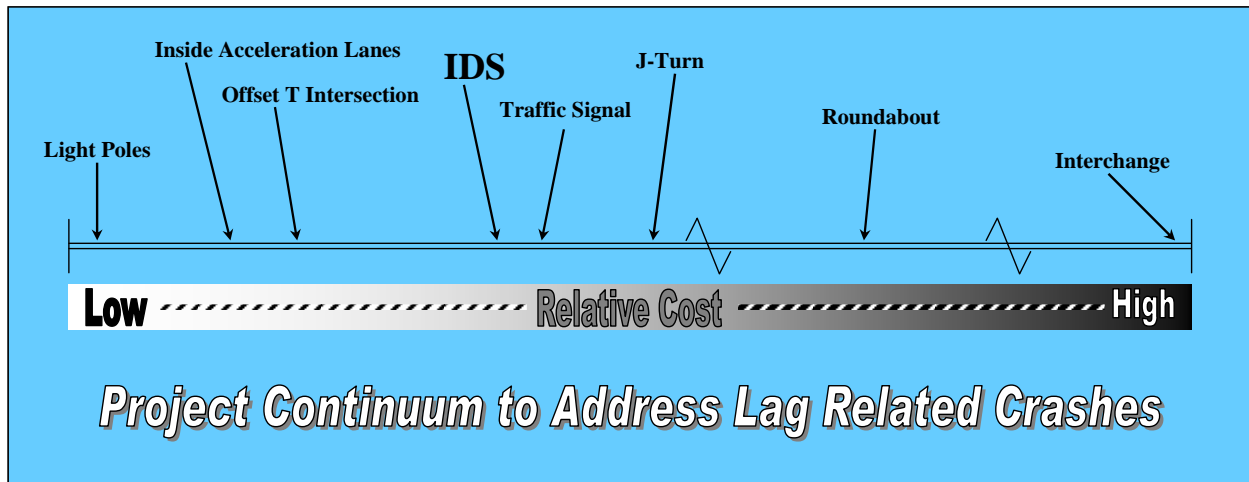
**FIGURE 1-1**  
Lag Selection Related Safety Strategies

- The use of supplemental devices such as street light poles to mark the threshold between safe and unsafe lags
- Minor geometric improvements to reduce conflicts at intersection such as inside acceleration lanes, channelized median openings to eliminate certain maneuvers (sometimes referred to as a J-Turn), or revising a 4-legged intersection to create off-set T's
- Installing a traffic signal to assign right-of-way to the minor street

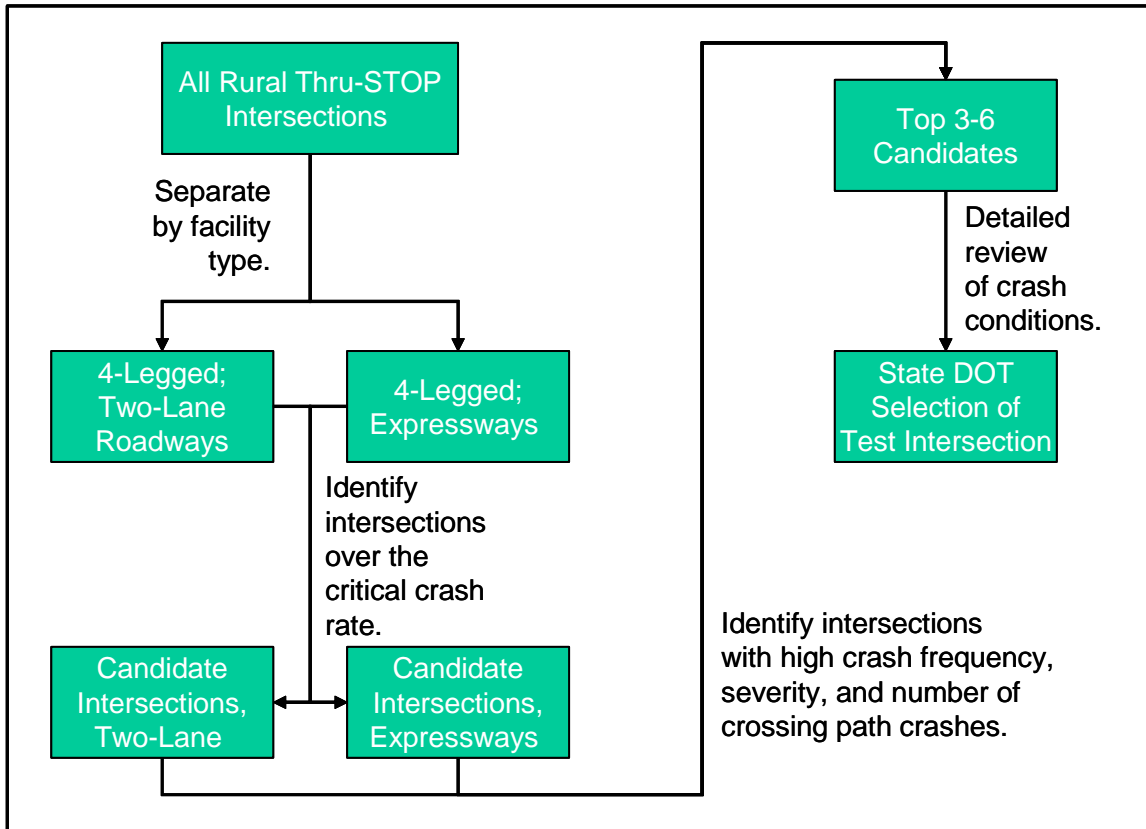
**FIGURE 2-1**  
Preferred Crash Analysis Process

A comprehensive method for intersection identification was developed using Minnesota’s crash record system (see **Figure 2-1**).

The method was applied to all rural, thru-STOP intersections in Minnesota, as this is the most frequent intersection situation in Minnesota. This intersection type is also the most likely where a driver will have to judge and select a lag at a rural intersection (i.e., stopped vehicle on the minor approach). The approach to identify the intersection selected for a potential field test of the technology used the three screens described in the following:

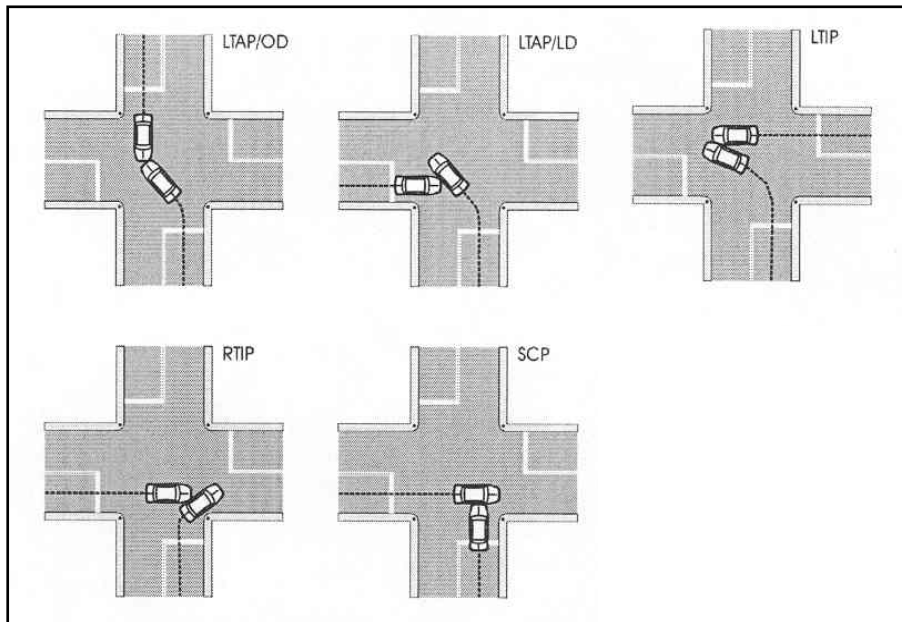
**FIGURE 3-1**  
GES Crossing Path Crash Types

The General Estimates System (GES) crash database is a national sample of police-reported crashes used in many safety studies. In the GES, five crossing path crash types have been identified (see **Figure 3-1**), they are:

- Left Turn Across Path – Opposite Direction (LTAP/OD),
- Left Turn Across Path – Lateral Direction (LTAP/LD),
- Left Turn Into Path – Merge (LTIP),
- Right Turn Into Path – Merge (RTIP), and
- Straight Crossing Path (SCP).

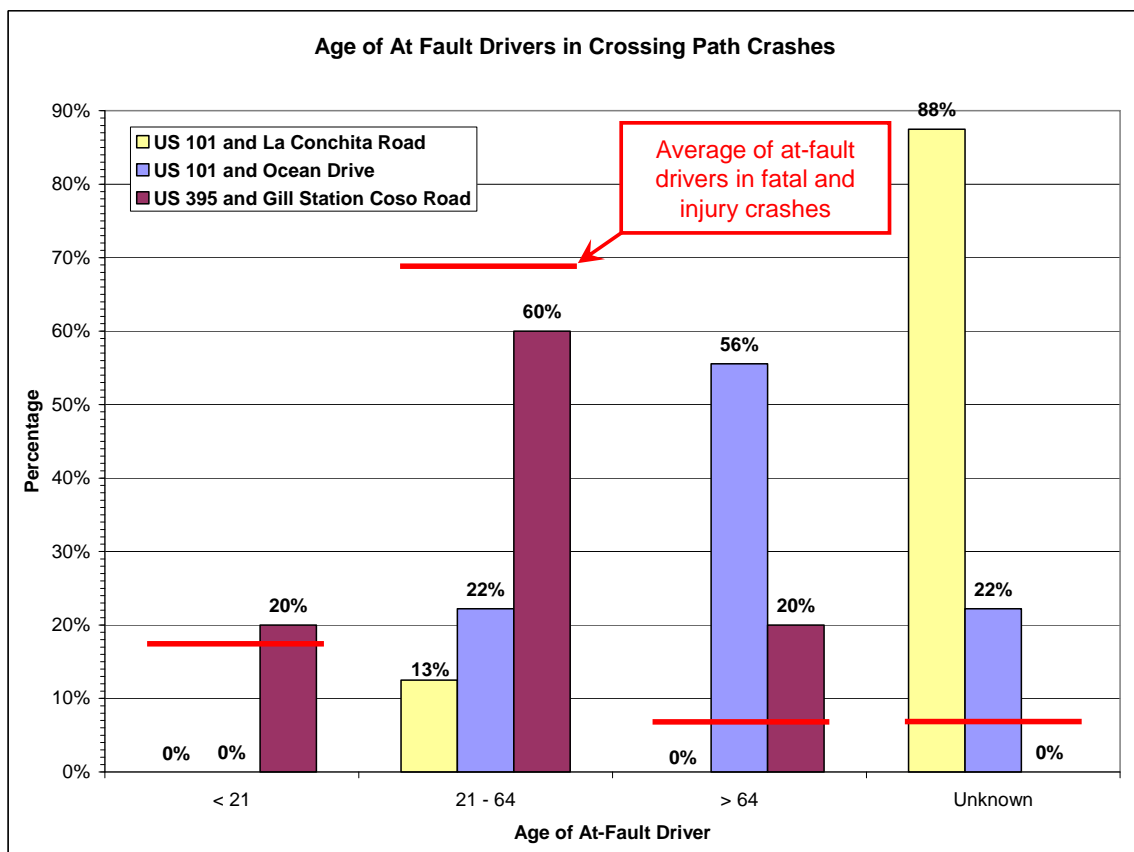
**FIGURE 3-2**

Age of At-Fault Drivers in Correctable Crash Types at the Candidate Intersections

For the candidate intersections, officer reports were reviewed to identify the driver whose action most likely caused the accident, also known as the at-fault driver (see **Figure 3-2**). Which driver was determined to be the at-fault driver was made using the narrative recorded by the investigating officer. For the at-fault drivers, the age was determined to be an important piece of information and was recorded because the IDS system may have its greatest benefit in assisting

At the intersection of US 101 and Ocean Drive, older drivers (age > 64-years) were determined to account for 56% of the at-fault drivers involved in the crossing path crashes. This is more than eight times greater than the statewide average of at-fault older drivers in fatal and injury crashes. At US 395 and Gill Station Coso Road, while the percentage of older drivers was above the statewide experience, it is considerably less than US 101 and Ocean Drive. As stated earlier, the driver information was removed from most of the officer reports at US 101 and La Conchita Road and prevented a similar analysis.

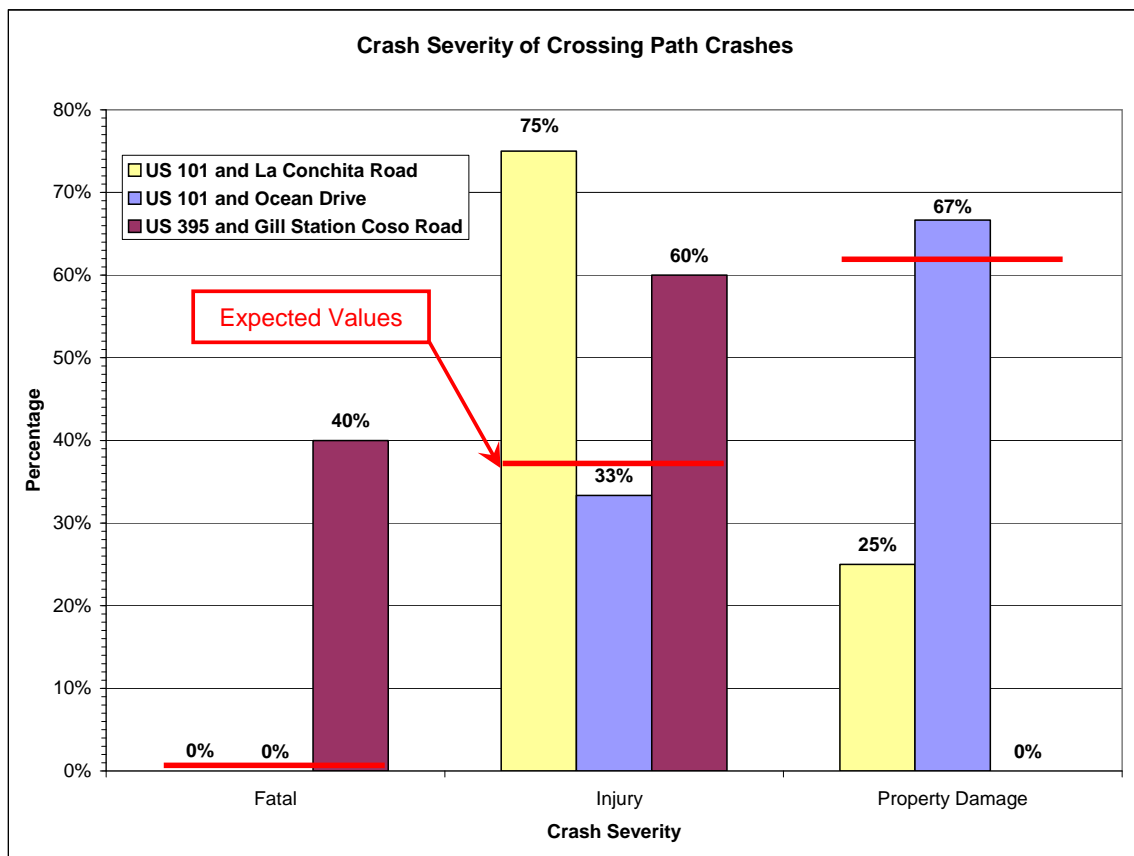
**FIGURE 3-3**  
Crash Severity of Correctable Crash Types at the Candidate Intersections

Another goal of the IDS system is to address the most serious intersections crashes, especially fatal crashes. Therefore, the most appropriate candidate intersection would have a high percentage of fatal and injury crashes. Of California’s 2005 crashes, fatal crashes represented approximately 0.7% of all of crashes, with injury crashes at 37.3% and property damage (PD) crashes accounting for 62.0% of all crashes (Source: *2005 Annual Report of Fatal and Injury Motor Vehicle Traffic Collisions*). **Figure 3-3** shows that neither intersection on US 101 had a fatal crash during the study period; however, this is not unusual given that fatal crashes are a rare event in comparison to injury and PD crashes. Of the two US 101 intersections, the percentage of crossing path crashes that resulted in an injury at US 101 and La Conchita Road was approximately twice the rate for all crashes in the state. The crash severity at US 395 was unusually high, with 40% of crashes resulting in a fatality and the remaining involving an injury.

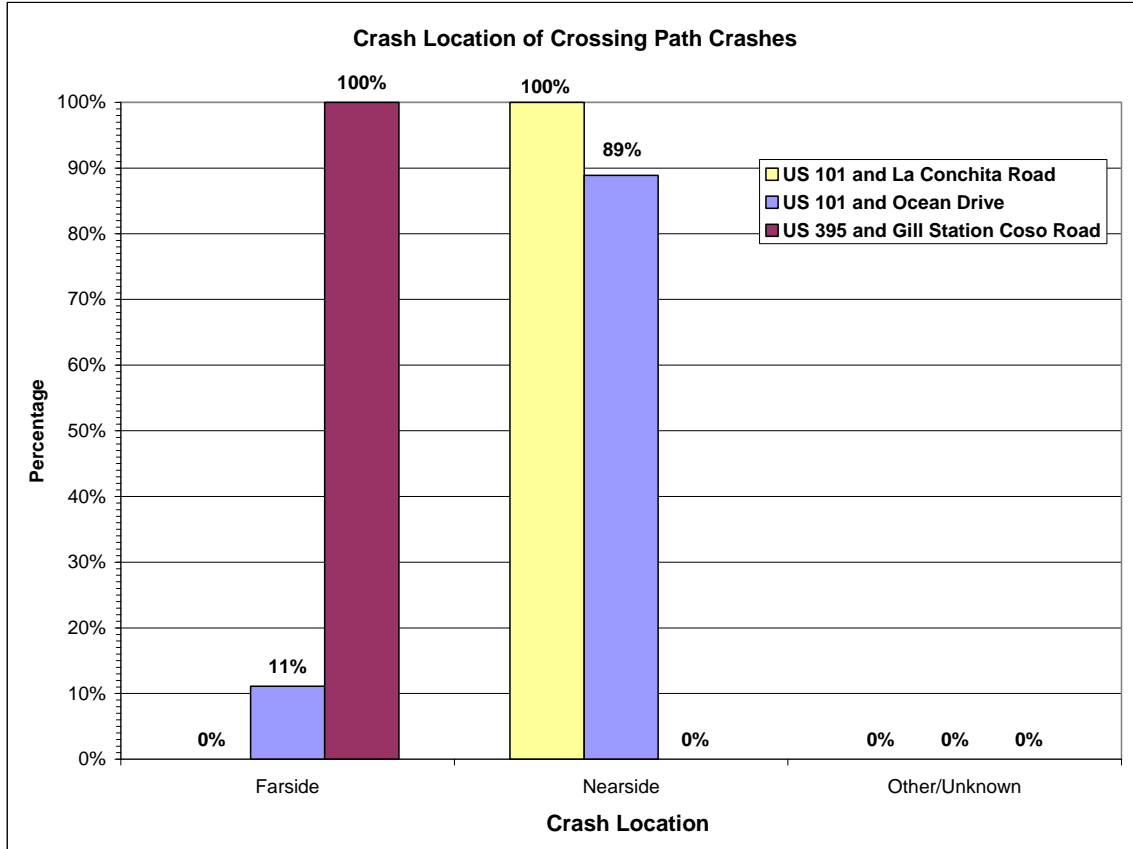
**FIGURE 3-4**  
Crash Location of Correctable Crash Types at the Candidate Intersections

At the US 101 locations (see **Figure 3-4**), nearly all correctable crossing path crashes were near-side crashes. This pattern is generally opposite of what was found in the other states that selected to study rural expressways. This may be a result of the T-intersection design or the left-turn median acceleration lanes which help prevent far side crashes. In contrast, all crossing path crashes at US 395 and Gill Station Coso Road were farside crashes.

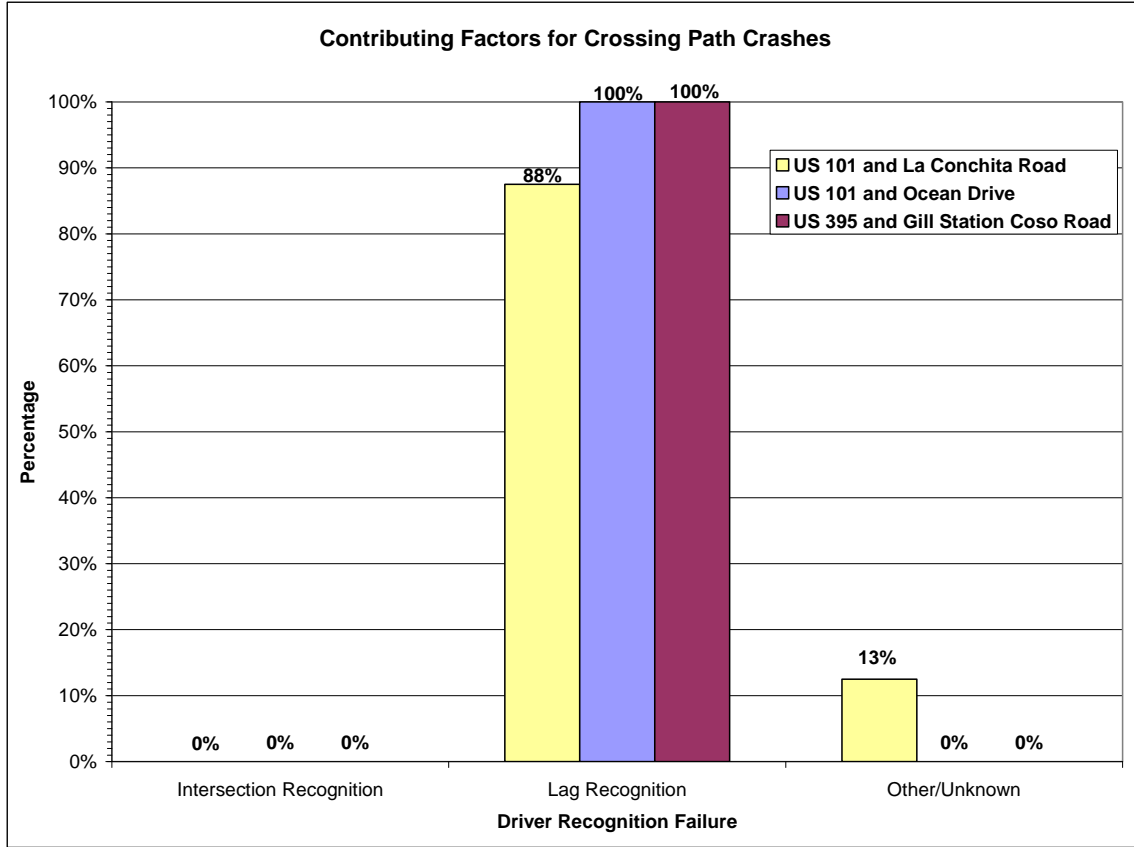
**FIGURE 3-5**  
Contributing Factors of Correctable Crash Types at the Candidate Intersections

As shown in **Figure 3-5**, 88% of the crossing path crashes at US 101 and La Conchita Road were lag recognition and all crossing path crashes at US 101 and Ocean Driver as well as US 395 and Gill Station Coso Road were lag recognition crashes. This strongly suggests that a high percentage of these crossing path crashes could have been prevented if the at-fault drivers had assistance in identifying, judging and selecting a safe lag.

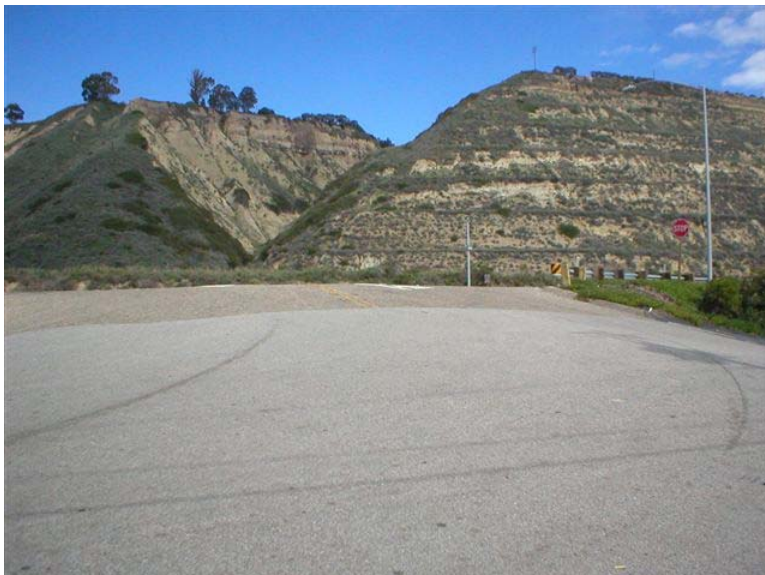
**FIGURE 4-1**  
Ocean Drive Approach

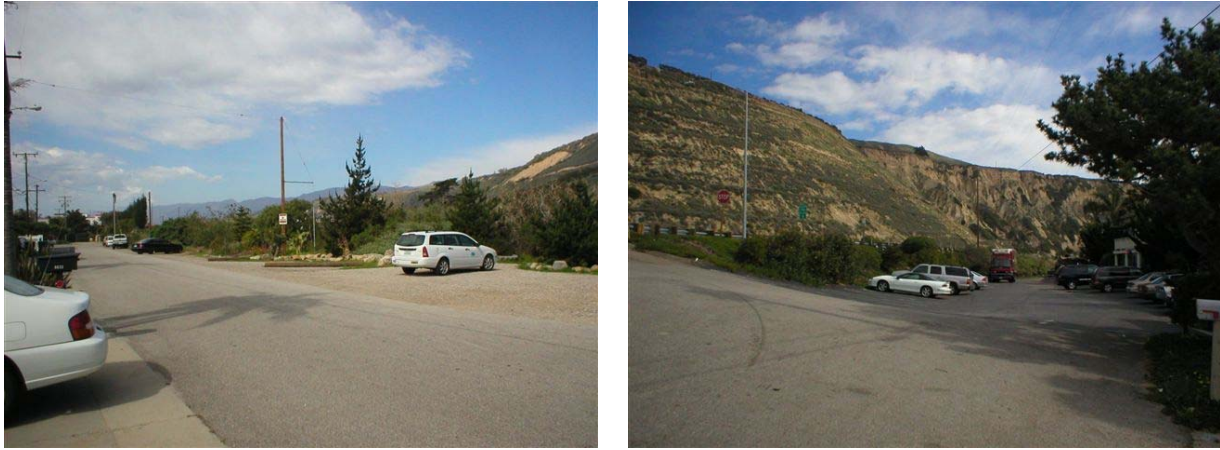
**FIGURE 4-2**  
Parking to the West (left photo) and East (right photo) of the Intersection

Ocean Drive is a low-speed roadway, serving local traffic and providing parking for local business (see **Figure 4-2**). In fact, immediately east of the intersection is a parking lot for the Cliff House Inn.

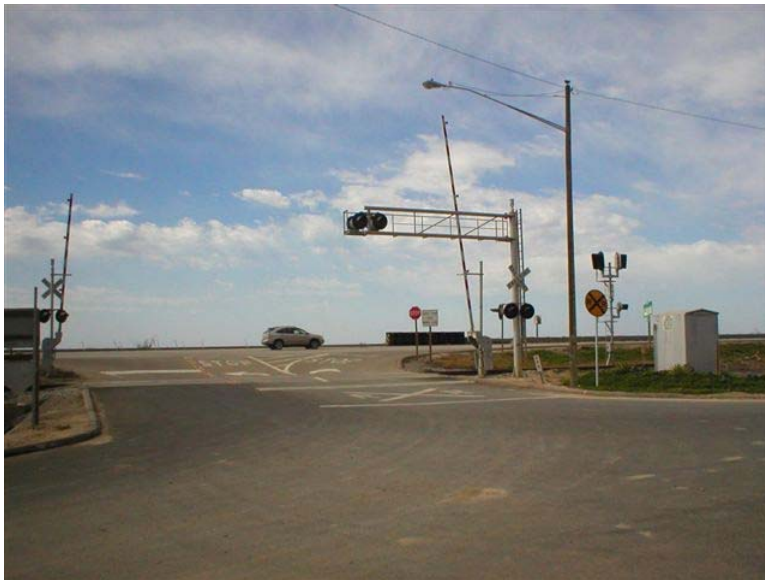
**FIGURE 4-3**  
La Conchita Road Approach

The La Conchita approach is shown in **Figure 4-2**. This photo also shows that a railroad track parallels US 101 and separates the Town of La Conchita from the highway. The at-grade railroad crossing include a gate with flashers. The photos from the CALTRANS also show that this intersection includes street lighting.

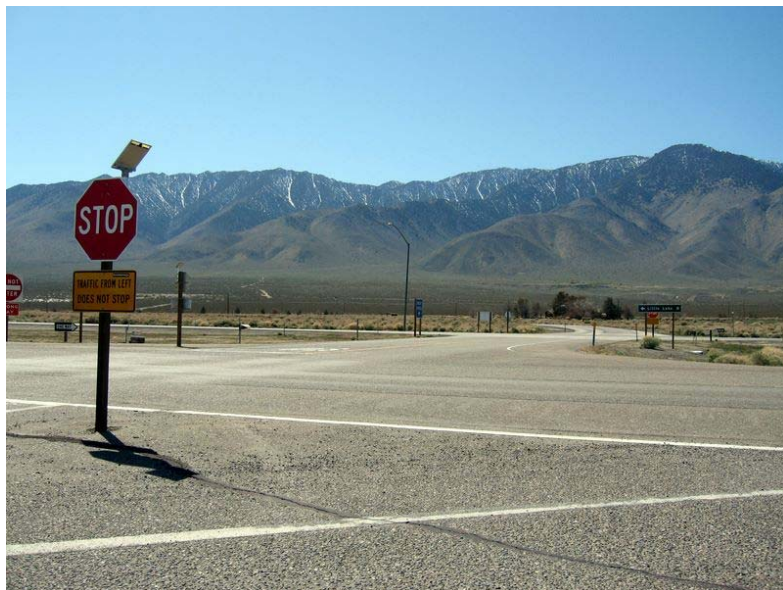
**FIGURE 4-4**  
View of Median from East  
Approach of Gill Station Coso Road

One unique aspect of this intersection is the wide median, which provides approximately 150 feet of storage in the median. Because of the extra storage space, STOP signs (instead of YIELD signs) have been placed at the each end of the median. Other safety countermeasures visible in Figure 4-4 include intersection lighting, warning signs mounted under STOP sign to remind drivers that traffic from left/right does not stop, and LED flashers around the face of STOP signs (powered by solar panels). Also visible in the aerial image (**Appendix B**) is an inside acceleration lane for vehicles turning left onto southbound US 395 and a free right for vehicles turning right onto northbound US 395.

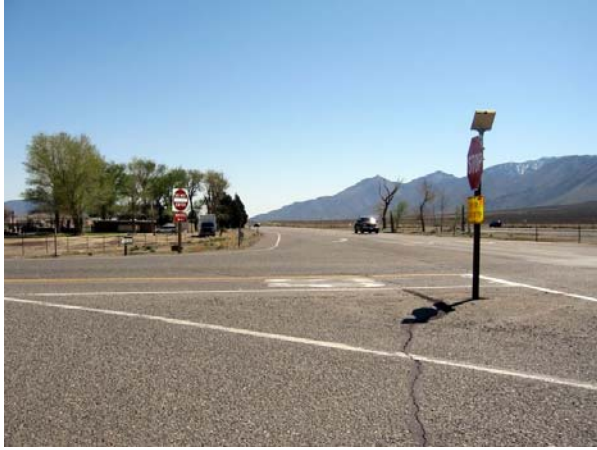
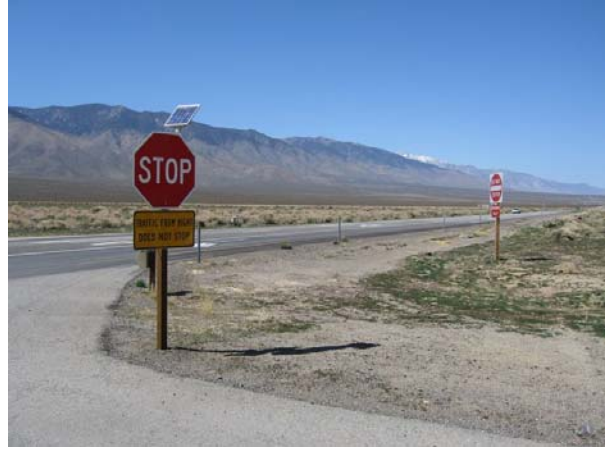
**FIGURE 4-5**  
View of US 395 Approach Alignment for Northbound (left photo) and Southbound (right photo) Traffic

The US 395 alignment in the vicinity of the intersection is straight and nearly flat (see **Figure 4-5**), which means drivers on Gill Station Coso Road or in the median have no alignment related obstacles to identifying approaching vehicles and judging lags. While the US 395 alignment doesn't create any barriers for entering traffic, it was observed that the placement of a DO NOT ENTER and WRONG WAY sign does create a large blind spot. The specific sign combination is in the driver's sight triangle when looking south from the median (see **Figure 4.6**). Interestingly, all five crashes at the intersection included vehicles making this crossing movement. However, the location of the sign was not specifically listed as a cause in any officer report.

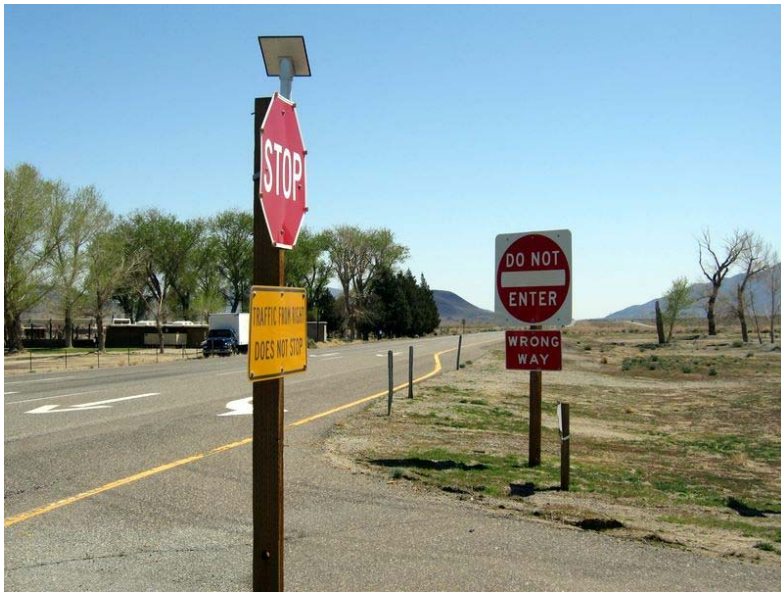
**FIGURE 4-6**  
Sight Obstruction While Looking South from the Median

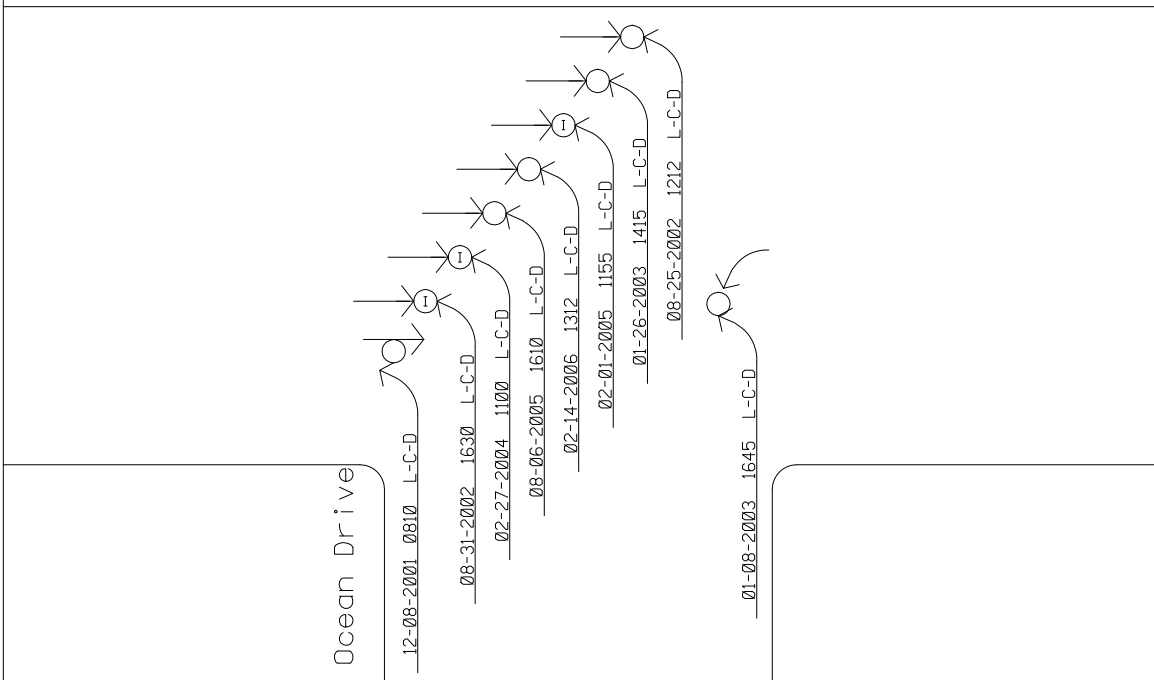
# Collision Diagram

Fatal=	0
Injury Total=	10
Property Damage=	14
Total Accidents=	24

The collision diagram in **Appendix A** reveals that eight of the nine correctable crossing path collisions involved a driver on the Ocean Drive approach turning left. Furthermore, all eight crashes involved a vehicle on US 101 approaching from the west (left).

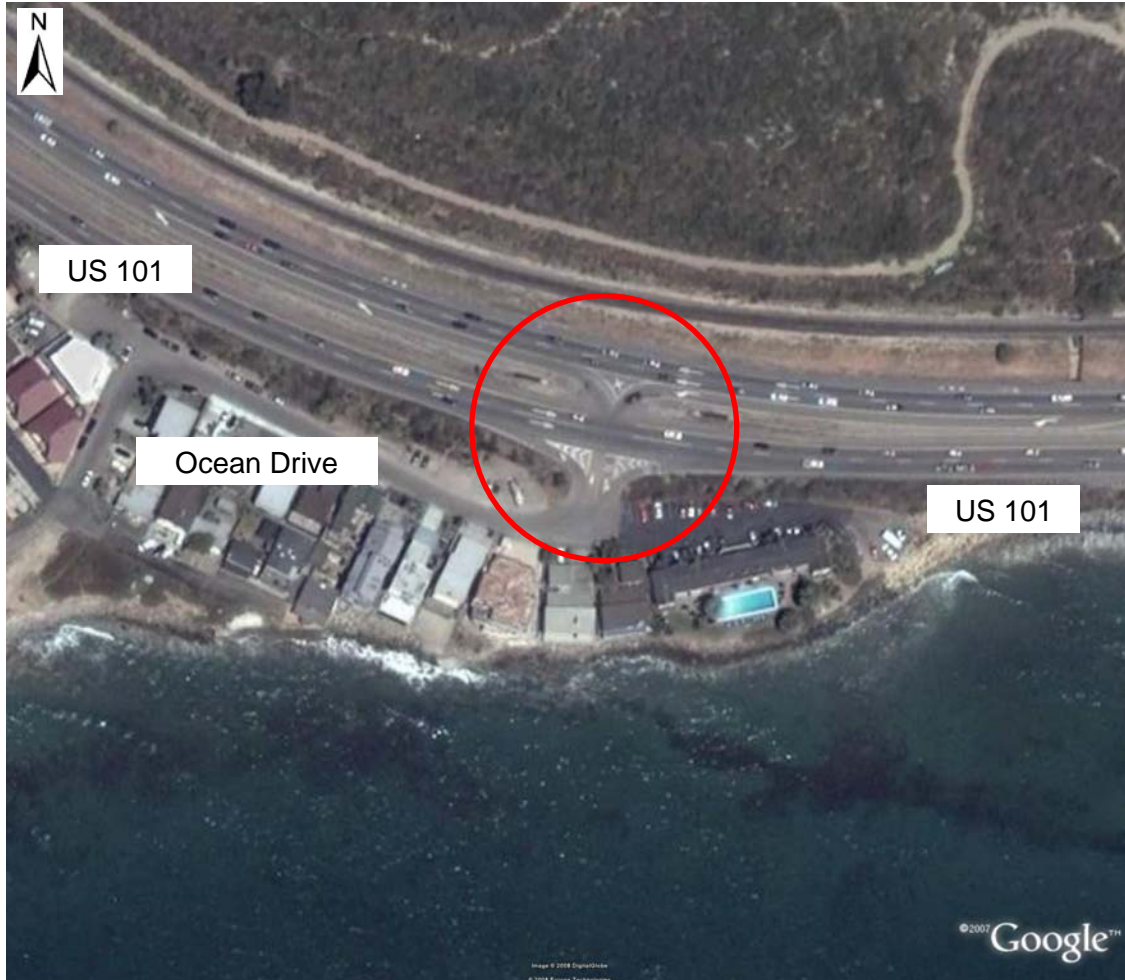
**FIGURE B-1**  
Aerial Photo of US 101 & Ocean Drive (Ventura County)

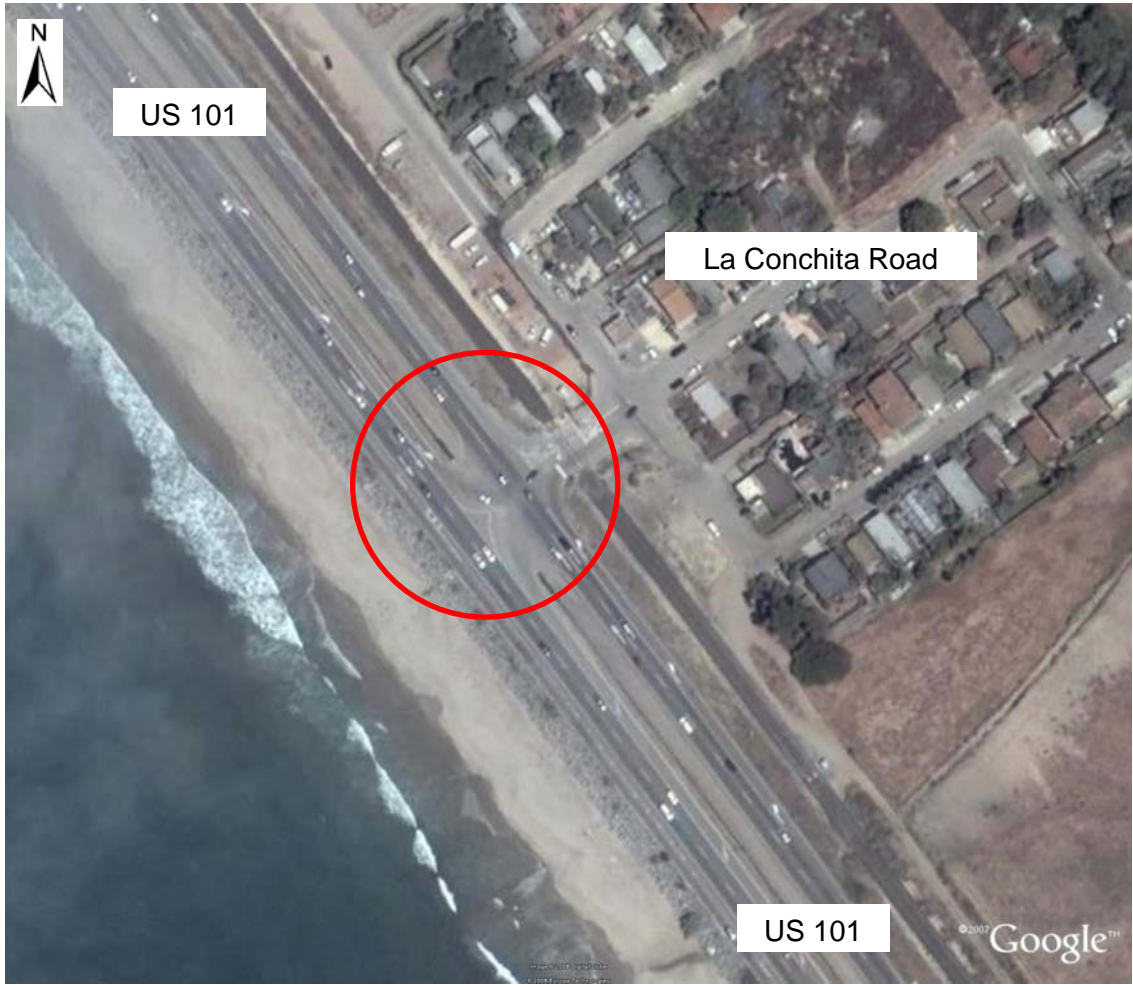
**FIGURE B-2**

**Aerial Photo of US 101 & La Conchita Road (Ventura County)**

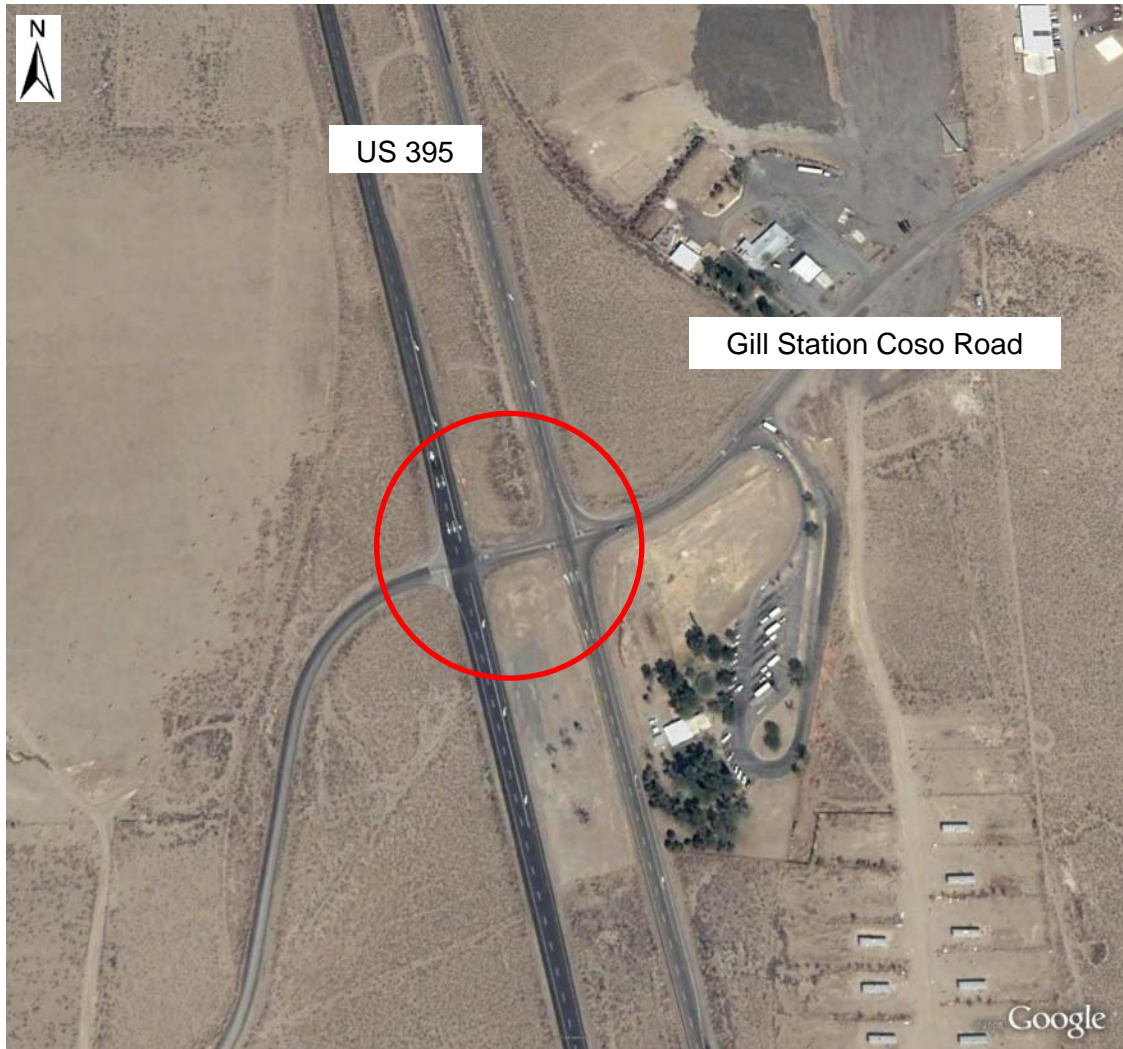
**FIGURE B-3**

**Aerial Photo of US 395 & Gill Station Coso Road (Inyo County)**
