# Tranverse Cracking In Concrete Bridge Decks

1. Report No. MN/RC - 1999-05	2.	3. Recipient's Accession No.	
4. Title and Subtitle TRANSVERSE CRACKING IN BRIDGE DECKS: SUMMARY REPORT		5. Report Date January 1999

## Summary Report

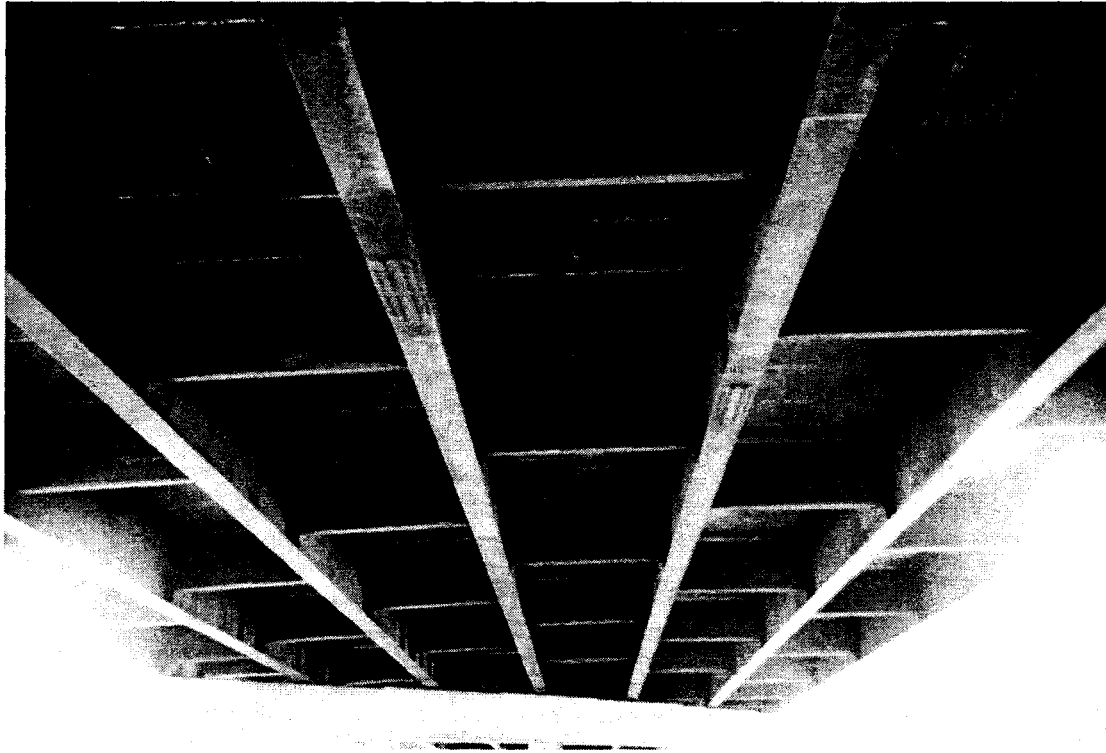
Figure 1 Bridge No. 19882: Span 2, looking north, showing cracking on bottom of deck  
[after (Eppers et al. 1998)]

For the steel girder bridges, only 12 of the 38 bridges rated a condition '8' or better. In general, interior spans on multiple span bridges (e.g., Figures 1-4) and curved portions of bridges (particularly inside portions of the curves) were in poorest condition, most likely due to higher restraint provided by these conditions (5,6). Bridge decks poured during unfavorable temperature conditions or with unfavorable mix proportions exhibited increased cracking (5).

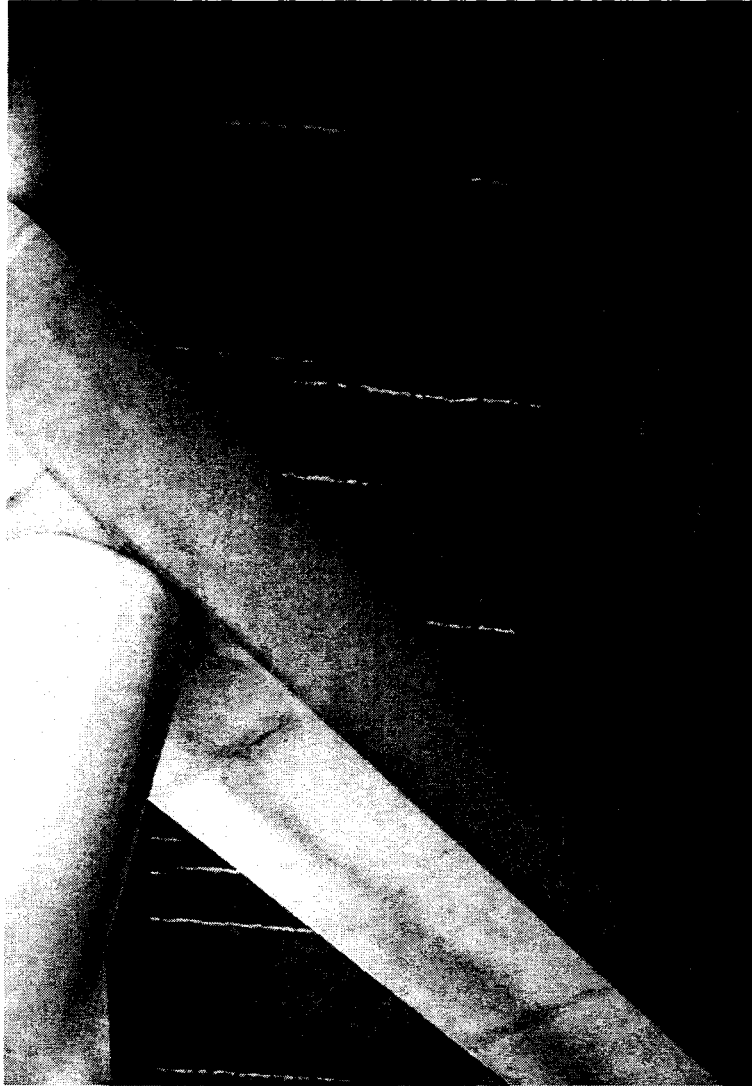
Figure 2 Bridge No. 19882: Pier 1 at west edge of bridge deck  
[after (Eppers et al. 1998)]
