A Research Plan and Report on Factors Affecting Culvert Pipe Service Life in Minnesota

Jeff Marr, Principal Investigator
St. Anthony Falls Laboratory
University of Minnesota

September 2012

Research Project
Final Report 2012-27

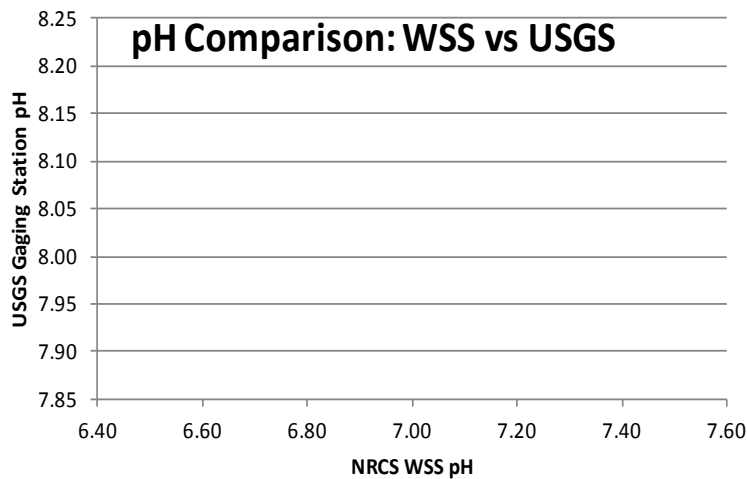
Figure 2 – pH comparison plot (Tabular data available in Appendix C)

The USGS has five gaging stations that have recorded pH and conductivity. The WSS does not have conductivity/resistivity data for any of these five locations. Figure 2 contains a pH comparison plot of the WSS pH data against the USGS pH data. Figure 2 shows there is no correlation between the pH of the USGS stream gages and the WSS soil data. The gaging site discharges (ranging from 60cfs to 7100 cfs) and drainage areas are much larger than the discharges and drainage areas for the typical MnDOT steel pipe. It is expected that the larger the drainage area, the less correlation will exist between soil and water pH because longer travel times allow more opportunity for bio/geo/chemical interactions.

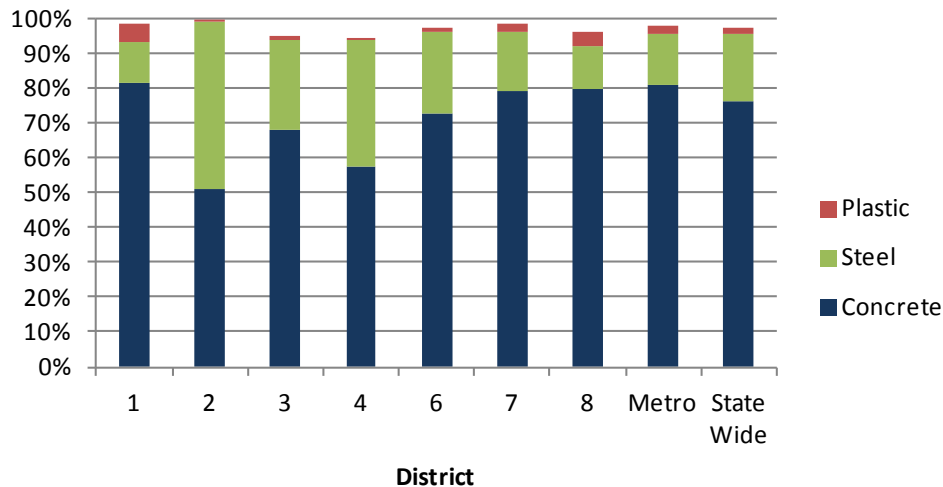
Figure 8 – In place pipe use by district

Table 2 and Figure 8 shows that concrete is the most popular pipe type state wide. Steel is the second most popular option. Nearly half of the pipes inventoried in District 2 are steel. Currently metal pipes are primarily used for entrances and each district has the options to inspect entrance pipes at its discretion.

Usage Statistics for Concrete, Steel, & Plastic Pipe
